## EARTHQUAKES AT UCB? THE HAYWARD FAULT, CAMPUS RETROFIT, AND THE SEISMOLOGICAL LABORATORY

**Field Trip Leaders:** Peggy Hellweg, Doris Sloan, Christine Shaff  
**Contributing Authors:** Donald Wells, Patrick Williams

## *Earthquakes at UCB? The Hayward Fault, Campus Retrofit, and the Seismological Laboratory*

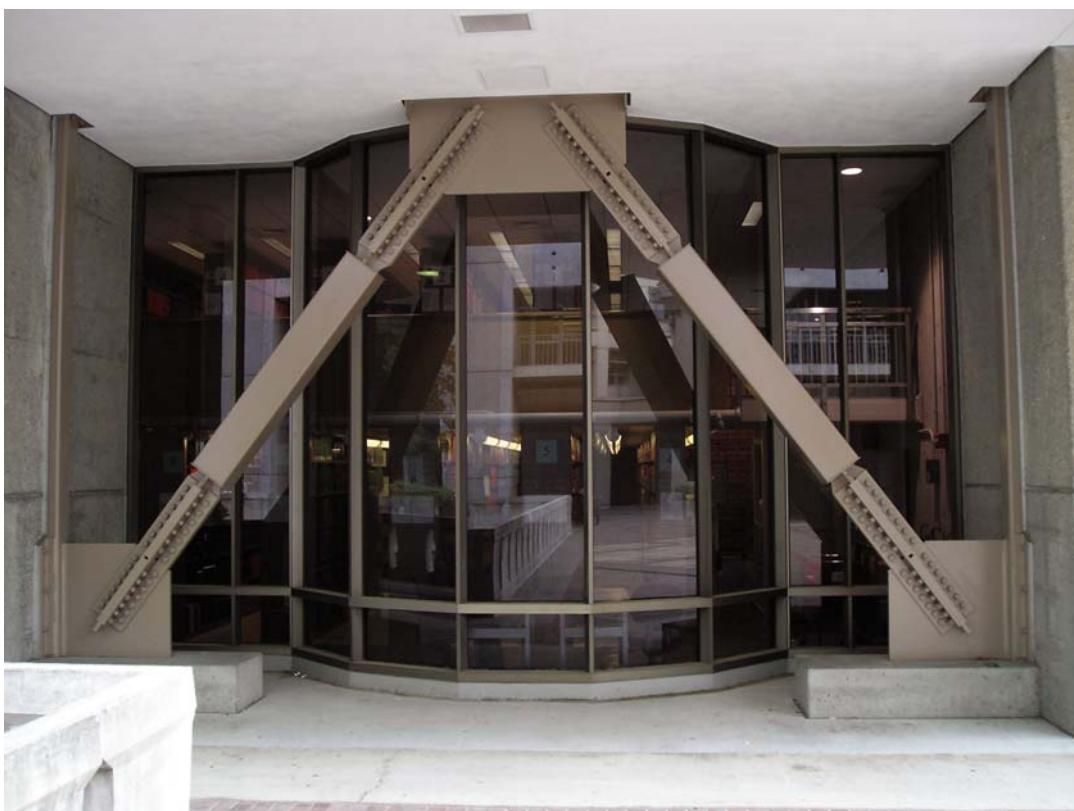
Figure 14. Hildebrand Hall: unbonded braces.

Anshen and Allen and Forell/Elsesser investigated numerous retrofit strategies for Hildebrand Hall and finally decided to use unbonded braces, which were a very new and promising addition to anti-seismic technology. You can see these braces on the plaza floor of the building (Fig. 14). Unbonded braces work in a simple and elegant manner. In a traditional steel cross brace, lateral forces are resisted axially by each cross-member. An applied lateral force will stretch one cross-member in tension and shorten the other in compression. Unbonded braces are made of both steel—which is strong in tension—and concrete—which is strong in compression, enabling the braces to exhibit nearly identical properties in both tension and compression. In addition to the braces, new concrete shear walls, providing lateral support, were added to the two lowest stories, and on the east and west side a portion of the shear walls extend up to the roof. The walls around the stair cores were strengthened and reinforcement was

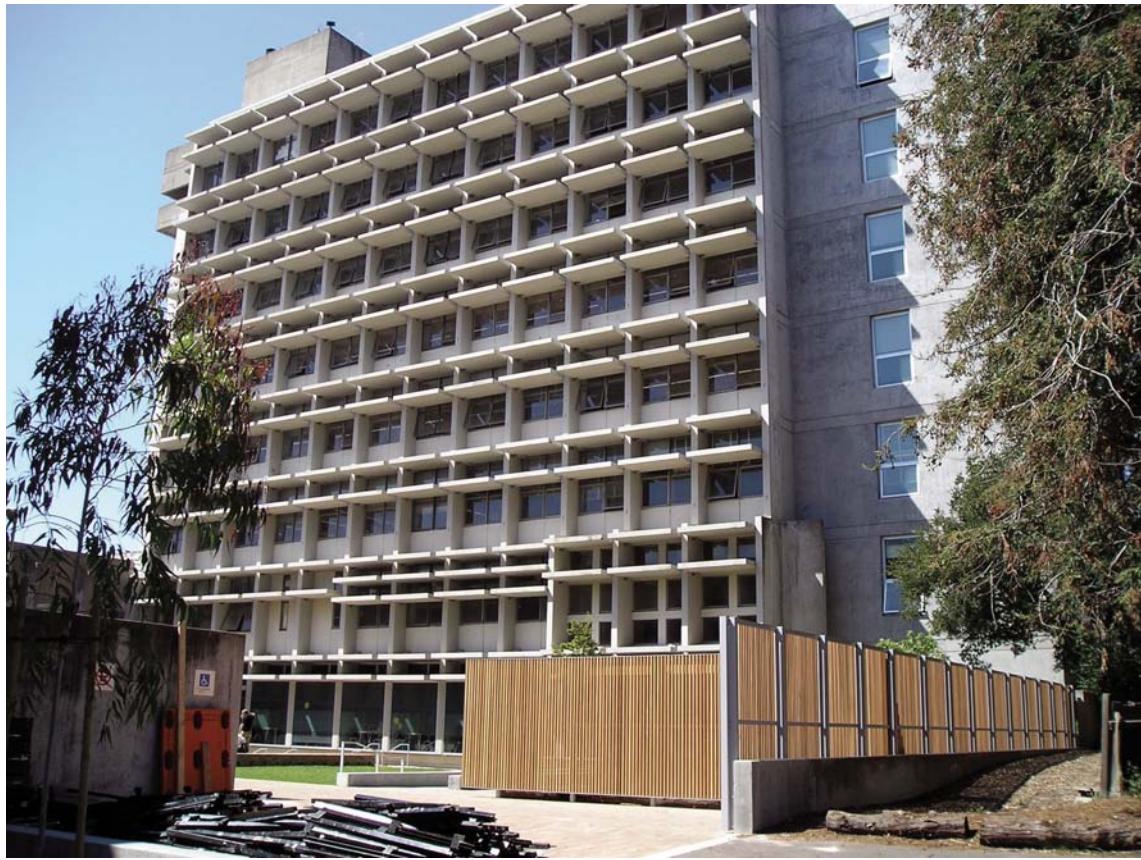
Figure 20. Wurster Hall Tower from the courtyard looking north.

Walk up to Wurster Hall and walk through and up the stairs to the courtyard. Look over to the tower for the most obvious retrofits (Fig. 20).

The project committee selected a design that involved adding a tube-like structure on the east of the tower and installing more continuous shearwalls on the west side of the tower, essentially creating two tubes. These tubes would brace the tower and provide lateral support. The tube scheme also included adding new shear walls and foundations to help resist lateral forces, minimizing potential displacement of the tower. Collector beams in the diaphragm were designed to tie the new

shear walls together with the existing structure, and two new foundations supported by drilled piers were added under the tubes. One tube, to the east, is clearly visible from the court yard. Walk back into the building and peer in a few offices: notice the steel columns. To strengthen the fin columns, steel columns were added on the interior of the façade to transfer the vertical loads.

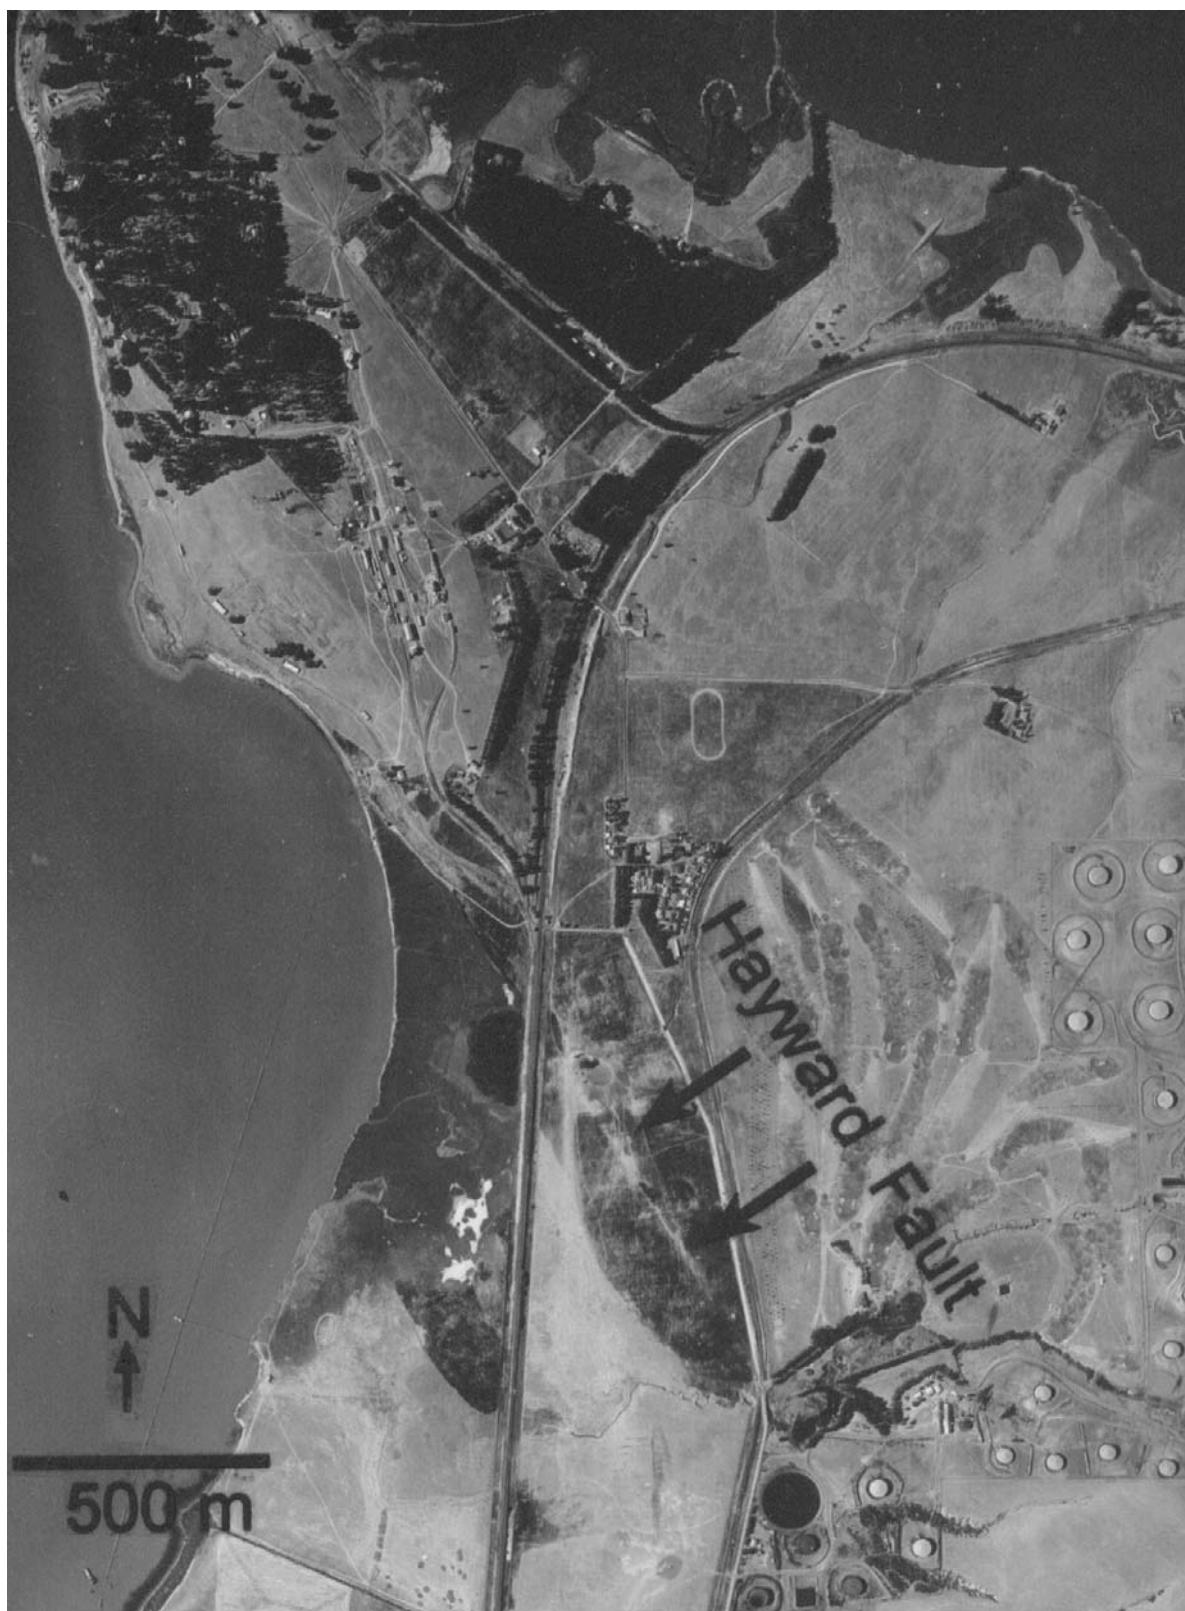
Figure 22. 1939 aerial photo showing the white linear feature that marks the location of the Hayward fault through what became Parchester Village in 1950. The white streak is the result of cultivation and erosion of an "E" soil horizon, which formed as a result of the water barrier produced by the fault. Most of the buildings seen here have been removed from the park.

Borchardt, and Lisowski, 1991), the Hayward fault crosses the southern boundary of the park (Fig. 23). The fault is delineated here by a small SW-facing scarp associated with a prominent white linear feature on 1939 air photos (Fig. 22). A series of benchmarks placed perpendicular to the fault by the USGS in 1968 underwent ~2.5" (65 mm) of aseismic displacement between 1968 and 1980 (5.3 mm/yr; Harsh and Burford, 1982). A real-time creep station was installed across the fault in 1996, yielding steady creep measurements of 4.8 mm/yr in a 50-ft-wide (15-m) zone from 1996 to 2004 (Bilham, 2005).

The strong linear feature on 1939 aerial photos (Fig. 22) was shown during seismic trenching to be a light gray “E” hori-

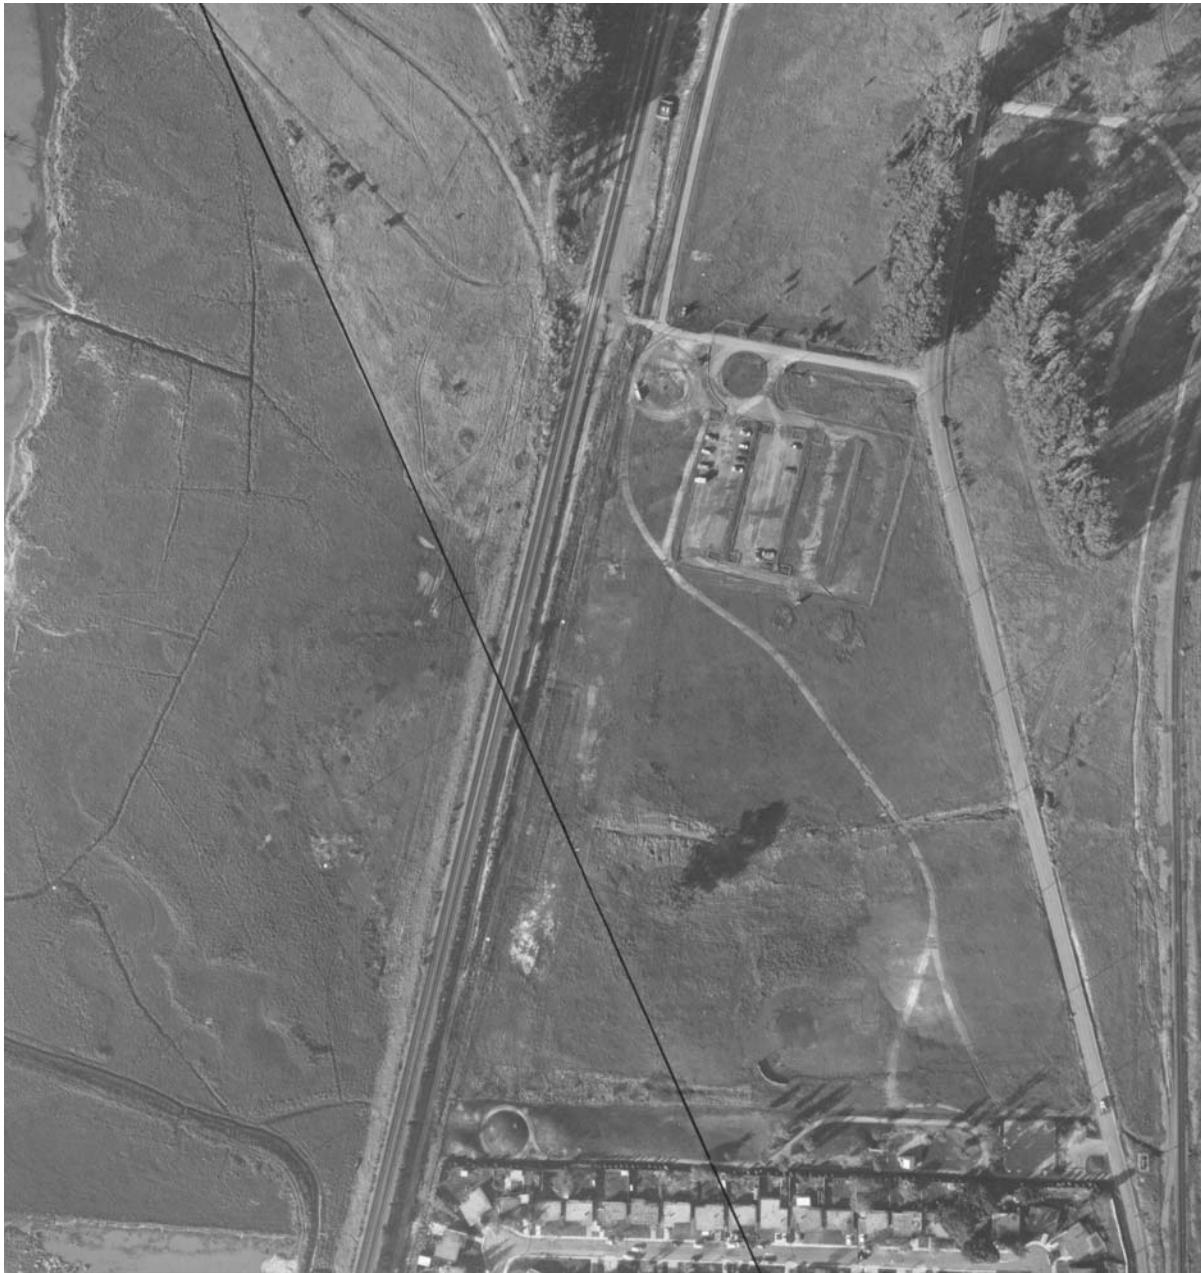
Figure 23. 1978 aerial photo of the Hayward fault as it passes through Parchester Village, offsets two pipelines and the Union Pacific railroad tracks, and then forms the linear scarp along the tidal marsh.

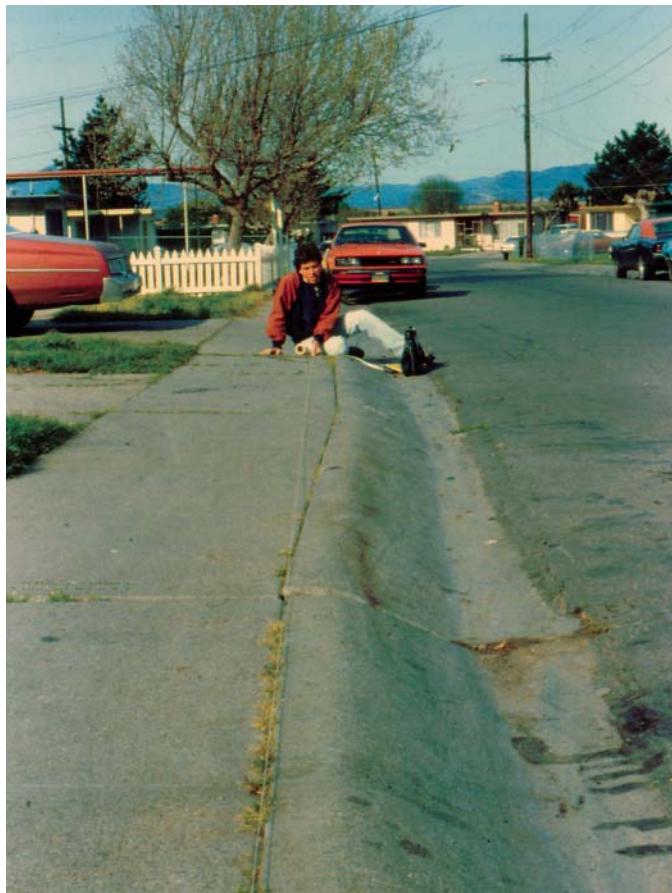
Figure 24. Right-lateral curb offset at 704 Phanor Drive due to aseismic slip in Parchester Village that was 150 mm (6 inches) by 21 March 1985. More precise techniques found 214 mm of offset in a wider span of the northwestern curb on Banks Drive in 1988 (Lienkaemper et al., 1991). By now, the offset should be about twice as much as shown here. Gene Kelley, Colorado State University, for scale.

After bisecting several houses, streets, and curbs (Fig. 24) in Parchester Village at 5.6 mm/yr since 1950 (Lienkaemper,

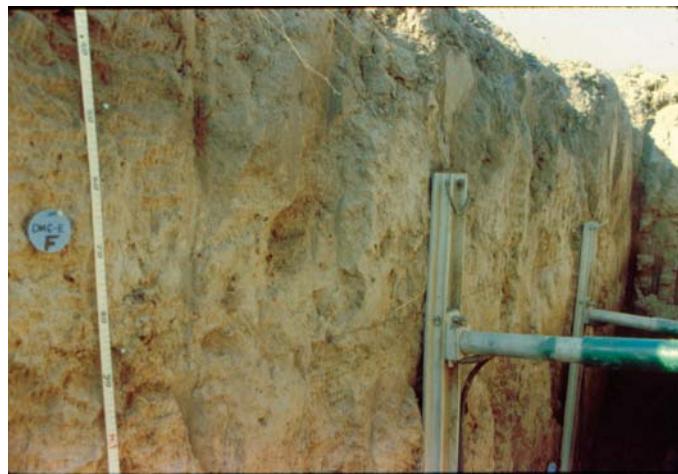
Figure 26. Light gray “E” horizon developed on the NE side of the Hayward fault in Trench DMG-E, a few meters from the soil profile in Figure 25 (Borchardt, 1988a).

zon (a soil horizon depleted of organic matter and iron oxides) formed in response to the water barrier formed by the fault (compare Figs. 25 and 26) (Borchardt, 1988a). The shallow water table helped to preserve spectacular slickensides at the 13-ft (4-m) depth (Fig. 27). The area is still nearly level today because vertical slip along the fault diminishes as it steps over to the Rodgers Creek fault to the northwest.

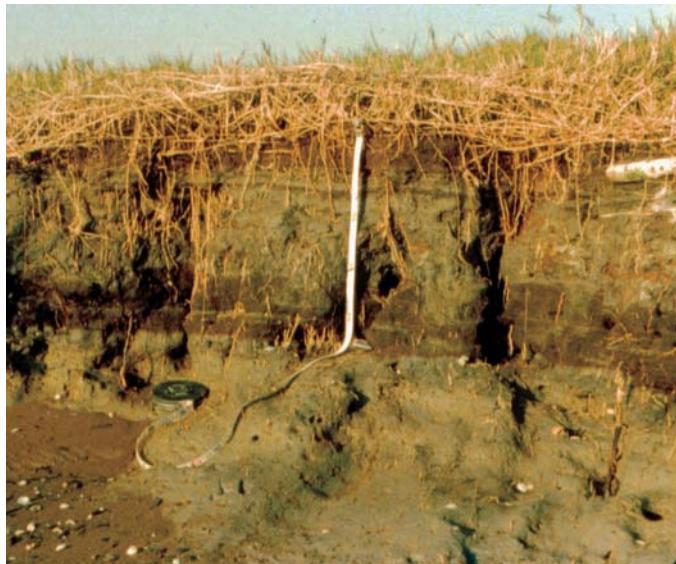
Figure 30. Bay mud cliff showing the younger bay mud and the pervasive sedimentary peat at the base that was dated at 1300 calendar years old.

A 1300-yr-old black sedimentary peat containing sand-size flakes of vermiculite (flakes of weathered biotite mica sometimes mistaken for gold in Sierra streams) lies buried in the tidal marsh southwest of the fault (Figs. 29 and 30). Examination of the salt marsh cliff and probings throughout the marsh revealed that the base of this distinctive peat layer exists at depths between 14" and 30" (36 and 75 cm) and that it varies in thickness from 4" to 11" (10–27 cm). Its depth and age are what would be expected in a crustally stable part of the world such as Micronesia (Bloom, 1970). Global sea level rise has been ~0.4 mm/yr during the past 4000 years, but measurements at the

Modern plant remains of the type found in the dated peat layer may be seen here mixed with vermiculite particles at the edge of the mud flat (Fig. 30). At low tide, the peat layer is exposed within the bay mud deposits along the full length of the salt marsh cliff. Bay mud is of mixed clay mineralogy and normally contains only clay and silt. Sand, if any, is brought in locally from nearby upland drainages.

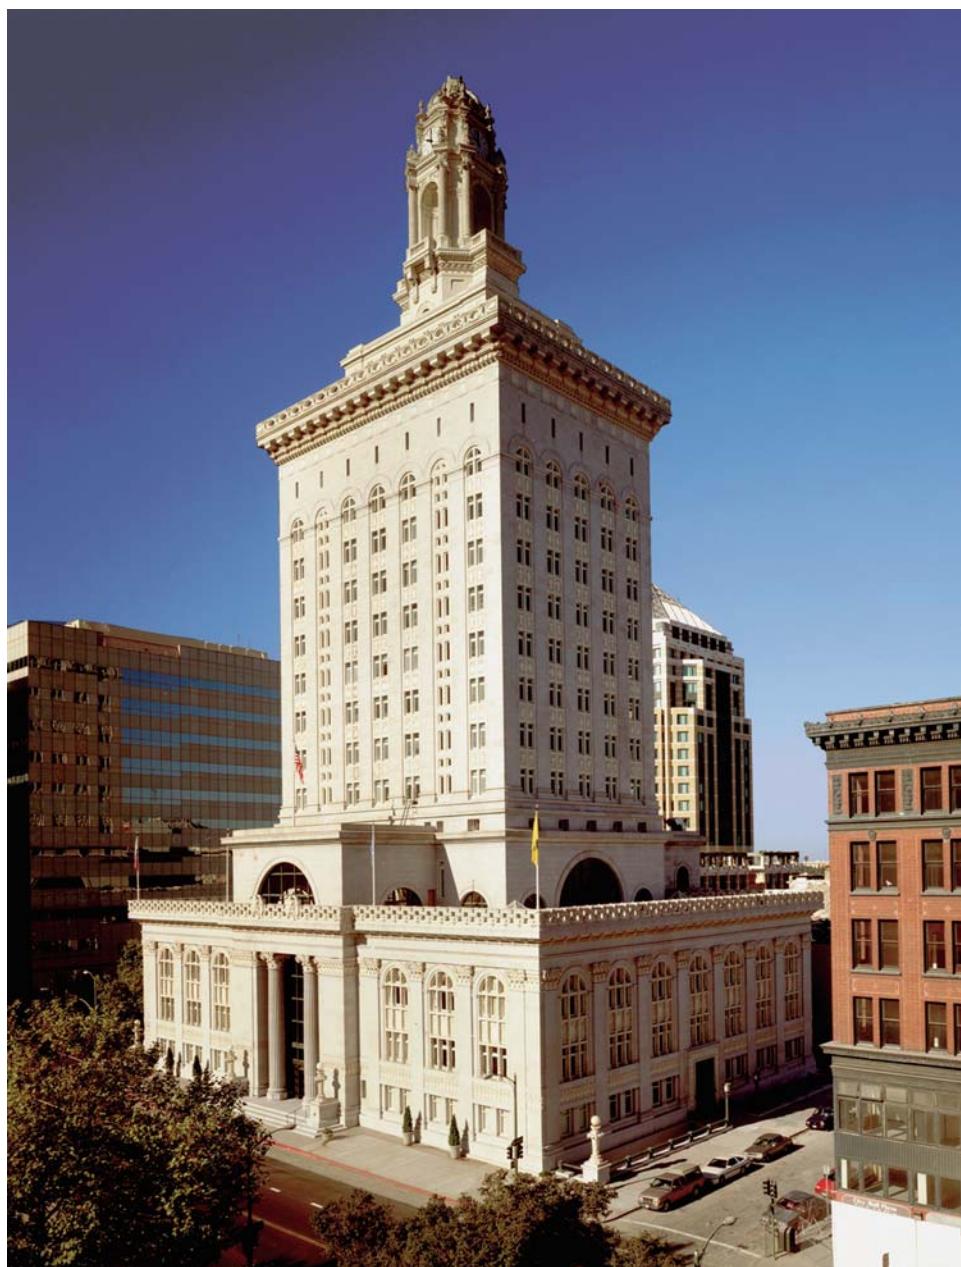
Figure 38. Photograph of Oakland City Hall (from Steiner and Elsesser, 2004).

tower, and a 2-story clock tower base that supports a 91-ft ornamental clock tower (Fig. 38). The total height of the building is 324 feet, and the total square footage is 153,000 sq. ft. The structural system is a riveted steel frame with unreinforced masonry perimeter in-fill walls clad with granite veneer and terra cotta ornamentation (DIS Inc., 2005).

The Oakland City Hall (Fig. 38) suffered significant damage in the October 1989 Loma Prieta earthquake, forcing the city to move all operations out of the building. The city hired a project team, headed by VBN Architects, to undertake a detailed feasibility study to quantify the building's lateral capacity and to examine alternative repair and strengthening schemes. The decision to install a seismic base isolation system as the most cost-effective solution was reached after eight alternative repair systems were compared and analyzed. A significant factor in the selection of base isolation as the most cost-effective approach was the limited strength of the building as constructed. To minimize the amount of new construction, the existing structure was given credit for the strength it exhibited during the Loma Prieta earthquake. This performance-based approach required less strengthening than conventional, code-based design, which ignores the existing capacity of the building.

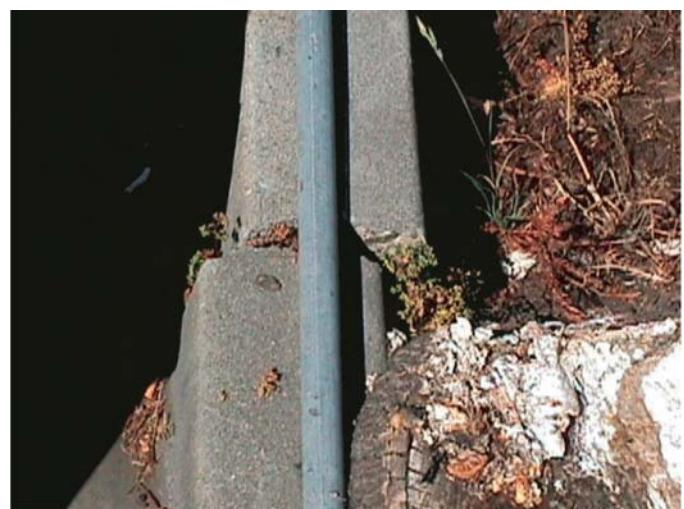
Figure 45. Photograph of evidence of right lateral creep on the mapped active strand of the Hayward fault. This offset curb is in the parking lot between A and B streets in downtown Hayward.

From City Hall, walk northwest along Mission Blvd, parallel to the creeping strand. Note that there is a little hill to the east. In addition to sliding right, the Hayward fault is also pushing its east side up ~0.5–1 mm/yr (Gilmore, 1992; Kelson and Simpson, 1995; Lienkaemper and Borchardt, 1996). Half a block past B Street, turn right into the City of Hayward parking lot. Here look for evidence of the creeping strand on the pavement, curbs, and nearby buildings (Fig. 45).

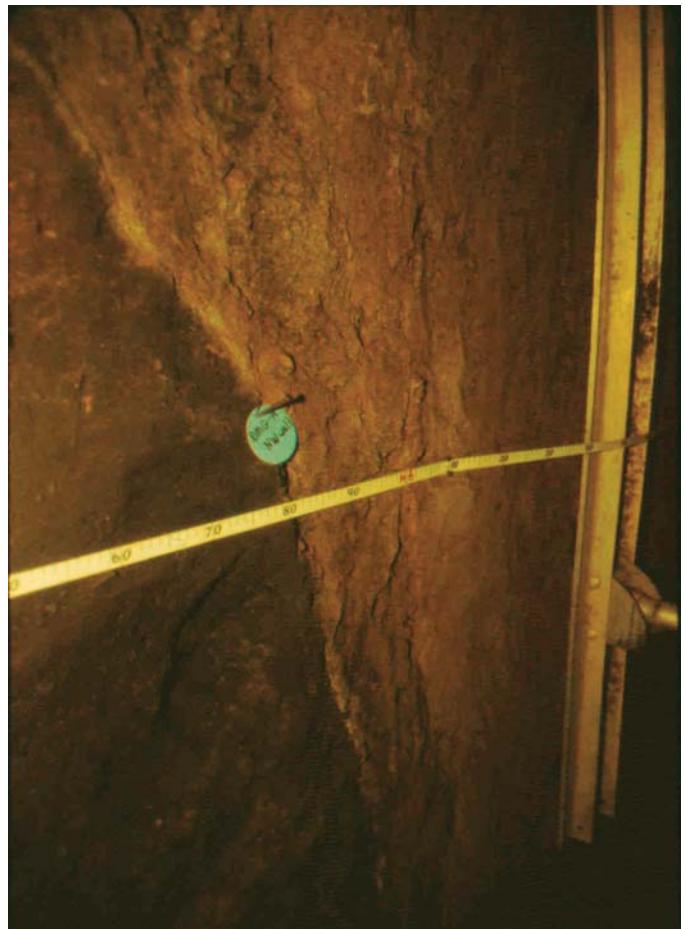
Figure 49. (this and following page) (A) Photograph of the Hayward fault exposure in a trench opened in 1987 on City of Fremont property (photo courtesy of San Jose Mercury News). The fault is a sharp boundary between fine-grained gray silt and light-colored sandy gravels.

This fault trench exhibit in Fremont's Central Park (Fig. 48) consists of an open pit that exposes the Hayward fault in a locality where the steep fault ruptured in 1868 and is easily observed in the different types of sediment (Fig. 49). The Fig. 49 photo comes from a trench located where the exhibit is today, ~150 feet north of the front of the former library (now the teen center). The public can observe the fault from the ground surface as well as walk down into the pit for a closer look. Visitors can also see where slow and constant creep along the fault is
